Assessment of Irrigation Land Suitability and Development of Map for the Fogera Catchment Using GIS, South Gondar

Citation: Dagnenet Sultan (2013) “Assessment of Irrigation Land Suitability and Development of Map for the Fogera Catchment Using GIS, South Gondar”, Asian Journal of Agriculture and Rural Development, Vol. 3, No. 1, pp. 7-17.

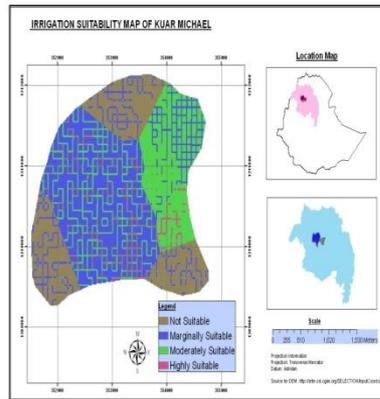
Figure 3: Overall Irrigation Suitability Map of the Study Area

The spatial suitability assessment for irrigation based on overlaid maps of parameters shows that about 72 percent of the study area were potentially suitable for irrigation. Of the potential suitable land, one percent was highly suitable, 28 percent was moderately suitable, and 43 percent was marginally suitable as shown in Figure 3.

The final objective of the study was to develop irrigation land suitability map of the study area. To reach on one final irrigation suitable map, a cartographic model for each suitability criteria was developed. Based on this cartographic model, an overlay analysis was done and one overall irrigation suitable map was developed. Irrigation suitable map was derived by overlaying all parameter maps. The total area was found to be highly

Based on area delineated, percentage and area coverage were determined. From texture map, 11 percent (76.7 ha) and 89 percent (625.5 ha) were found to be heavy clay and clay which implies highly suitable and moderately suitable, respectively. Water table depth map shows that 120-150 cm depth were found 35 percent (244.86 ha) area coverage whereas water table depth of 150-200 cm were found 65 percent (457.43ha). From flood hazard map had resulted into 76.7 percent (538.65 ha) and 23.3 percent (163.64 ha) moderately suitable and high suitable respectively.
